# LOWER PATAPSCO RIVER SMALL WATERSHED ACTION PLAN

## Volumes I and II

Baltimore County Department of  
Environmental Protection and Sustainability

*May 2012*

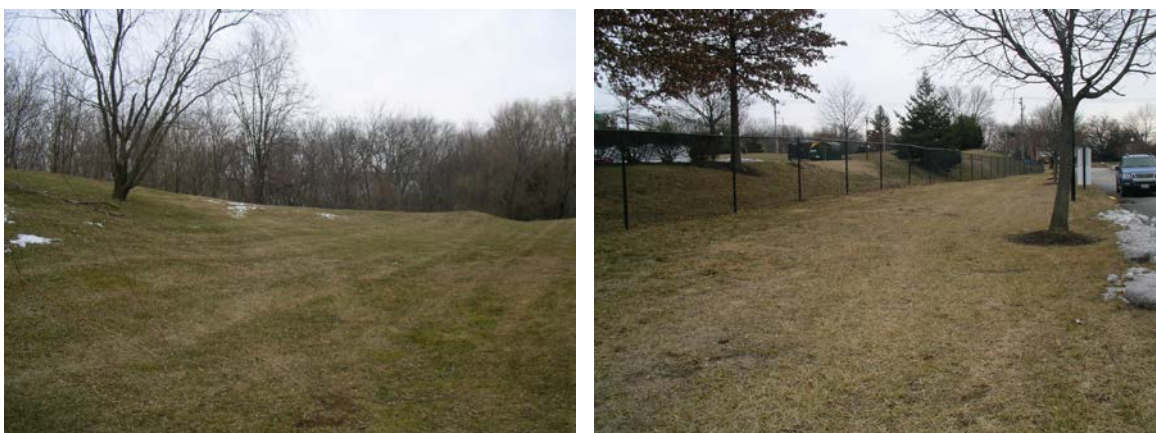
**Figure 4-3: Opportunities for Shade Trees in NSA-A-1038**

Each of the neighborhoods assessed within Dogwood Run had opportunities for improvement. Storm drain marking was recommended in three of the neighborhoods. This relatively easy and inexpensive action can have a great effect by reminding residents not to dump potentially dangerous materials into the storm drain. Rain barrels were also recommended in three neighborhoods to serve as temporary storage of roof runoff, decreasing the volume of stormwater running off site. One parking lot retrofit was suggested in NSA-A-1038, at the end of Flaxton Court, meaning implementing a BMP to capture and treat runoff from this impervious surface. Adding a bioretention area, a depressed area with native plants and filter media, could enable runoff from this lot to be captured and treated prior to entering the storm drain/stream system. Open space for shade tree planting was identified in NSA-A-1038, at the end of Flaxton Court and behind Chippenham Place (Figure 4-3), while opportunities for street trees were identified in NSA-A-1001 and NSA-A-1037.

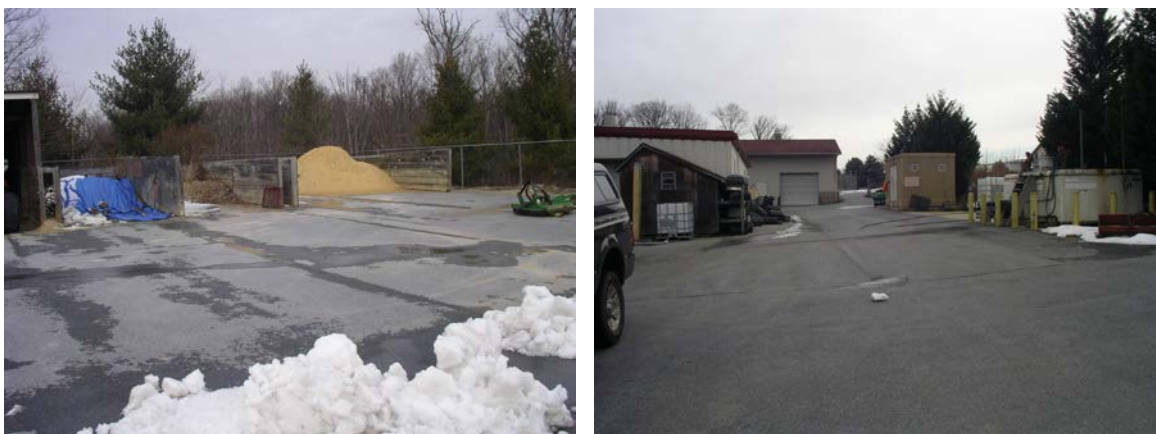
**Figure 4-4: Material Storage was Observed as a Potential Pollution Problem at ISI-A-102.**

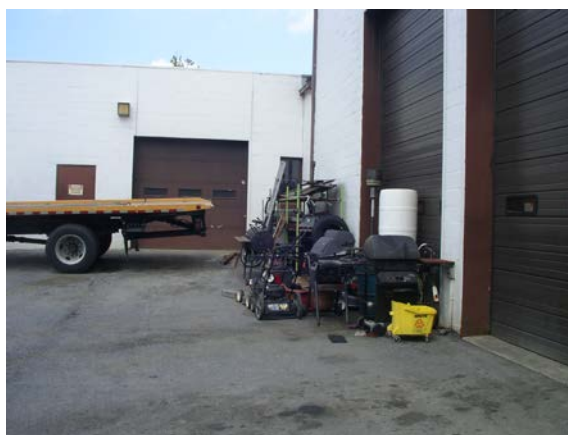
Material and waste storage and management were a major concern at ISI-A-303. This maintenance and fuel center included piles of tires, drums, propane tanks, uncovered waste oil tanks, picnic tables, and metal bleachers, as well as piles of stones, dirt, mulch, and tree debris (Figure 4-7). Vehicles stored on the property included county vehicles for maintenance and landscaping, buses, tractors, and construction equipment. A stream is present on the property, and is buffered by a very thin border of riparian cover, and thus is extremely susceptible to stormwater runoff from the site. The aforementioned poor material storage threatens this stream, making this institution one of the worst observed in the uplands assessment of Lower Patapsco River.

**Figure 4-7: Material and Waste Storage was Observed as a Potential Pollution Problem at ISI-A-303.**

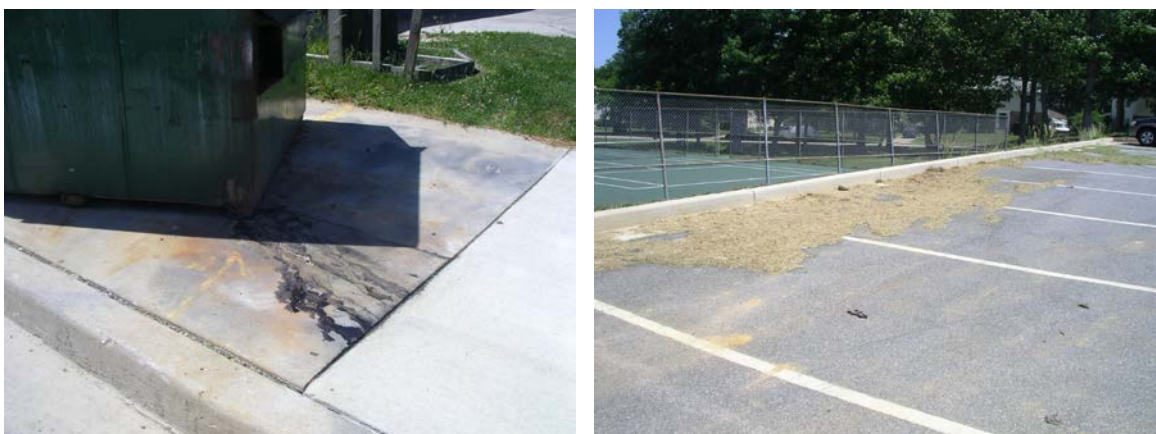
**Figure 4-8: A Leaky Dumpster and Excessive Grass Clippings Accumulated on the Parking Lot were Observed at ISI-A-306.**

At the public school (ISI-A-306), tree planting and storm drain marking were recommended as opportunities to combine water quality improvement measures with student education and outreach. Impervious cover removal was recommended at this site, where a small sidewalk that is no longer used could be removed. Decreasing impervious cover allows for better infiltration of stormwater on-site. A leaky dumpster was observed at the school, and accumulated grass clippings and leaves were observed on impervious surfaces on school grounds (Figure 4-8). Cleanup of these stormwater threats is an opportunity to educate students and staff of the importance of trash and materials management.

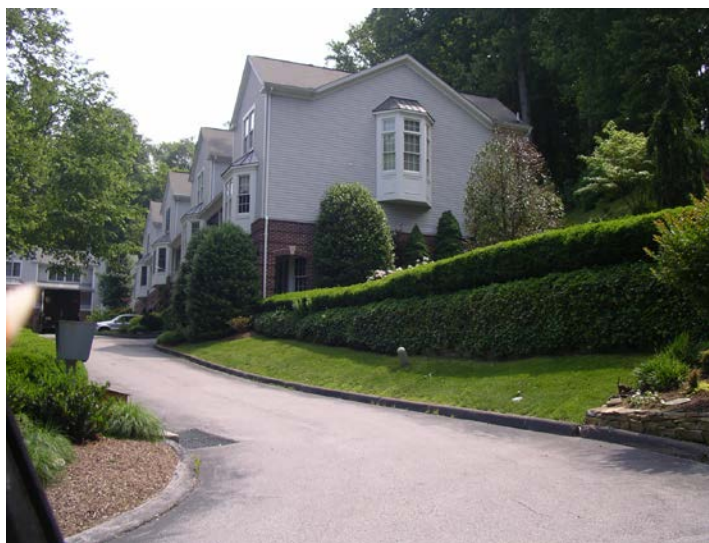
**Figure 4-10: Small Lot Sizes and a Lack of Yard Space are Characteristic of NSA-A-1030.**

Lot sizes tend to be smaller in this watershed, so a combined effort of downspout disconnection and rain barrel education programs would work well. The small lot sizes also limited opportunities for planting shade trees (Figure 4-10). There was very little space between the street and the sidewalk in the neighborhoods surveyed, so areas for planting street trees was limited, as well. Two neighborhoods were recommended for parking lot retrofits, meaning implementing BMPs to capture and treat runoff from these impervious surfaces (Figure 4-11).

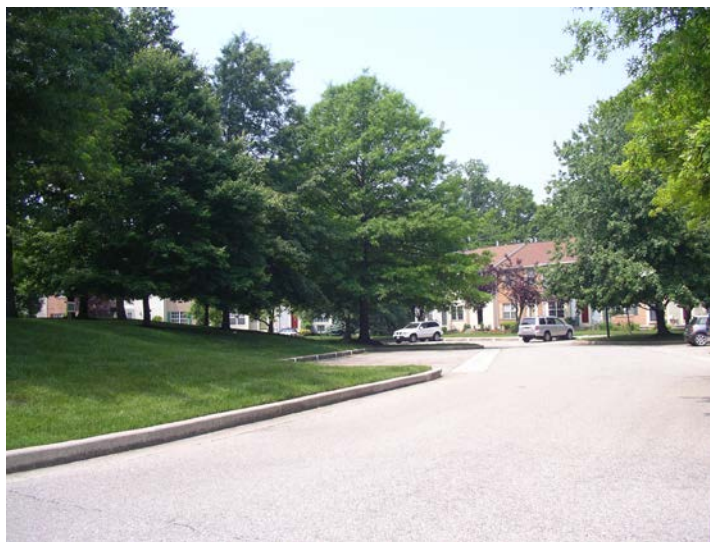
**Figure 4-11: There was an Opportunity for Parking Lot Retrofits in NSA-A-1028.**

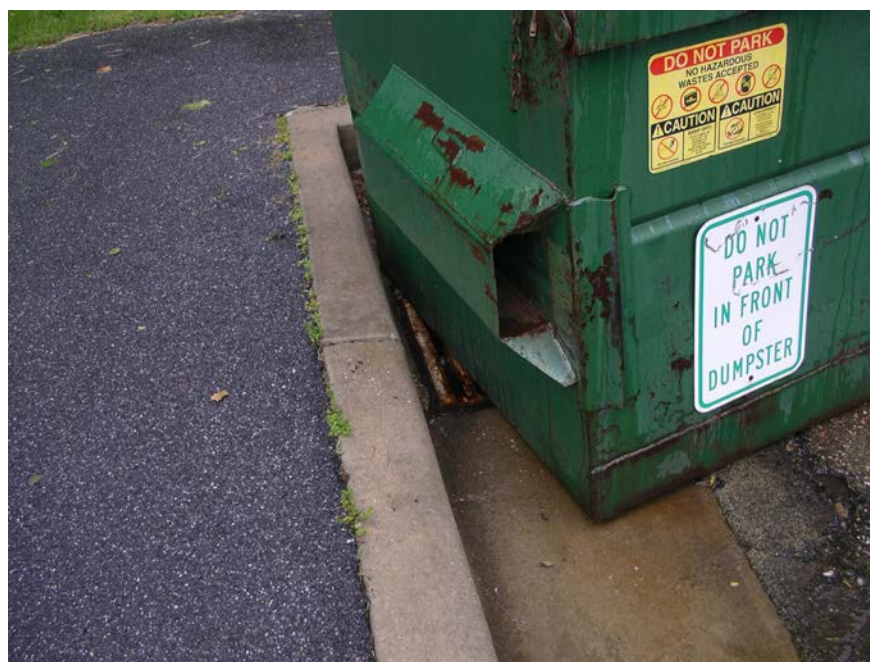
**Figure 4-12: A Dumpster Sits Perilously Above a Stormwater Inlet at ISI-A-407.**

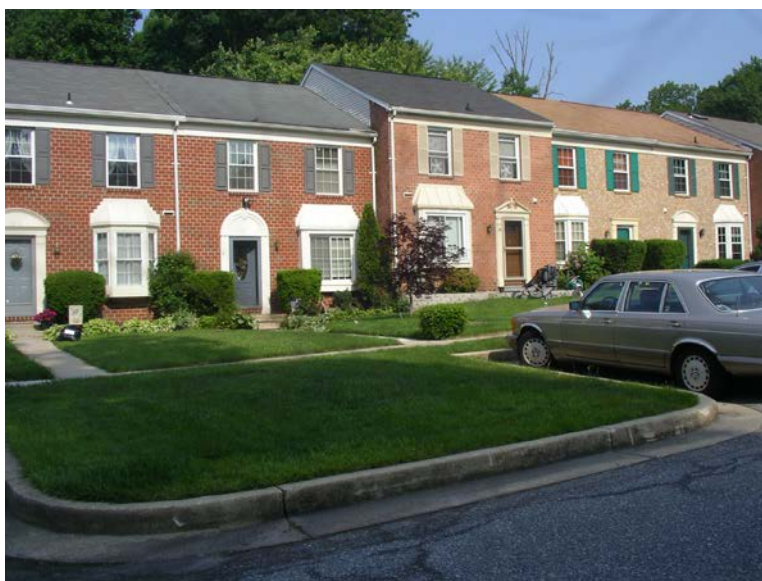
**Figure 4-14: Green Space Within a Townhome Community Provides an Opportunity to Plant Street and Shade Trees in NSA-A-1000.**

Storm drain marking was recommended for all but one of the neighborhoods in this subwatershed, which offers an opportunity to not only engage residents, but to serve as a visual reminder of the downstream effects of residents' actions. Several townhome communities, particularly in NSA-A-1000, have patches of unused green space that provide excellent opportunities for planting street and shade trees (Figure 4-14).

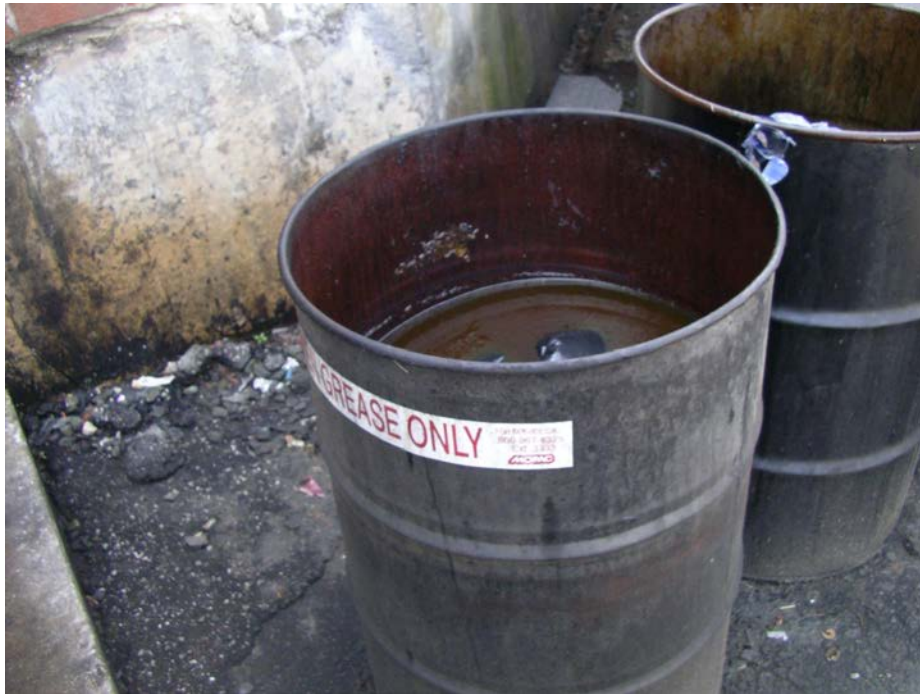
**Figure 4-15: Uncovered Grease Drums at HSI-A-505**

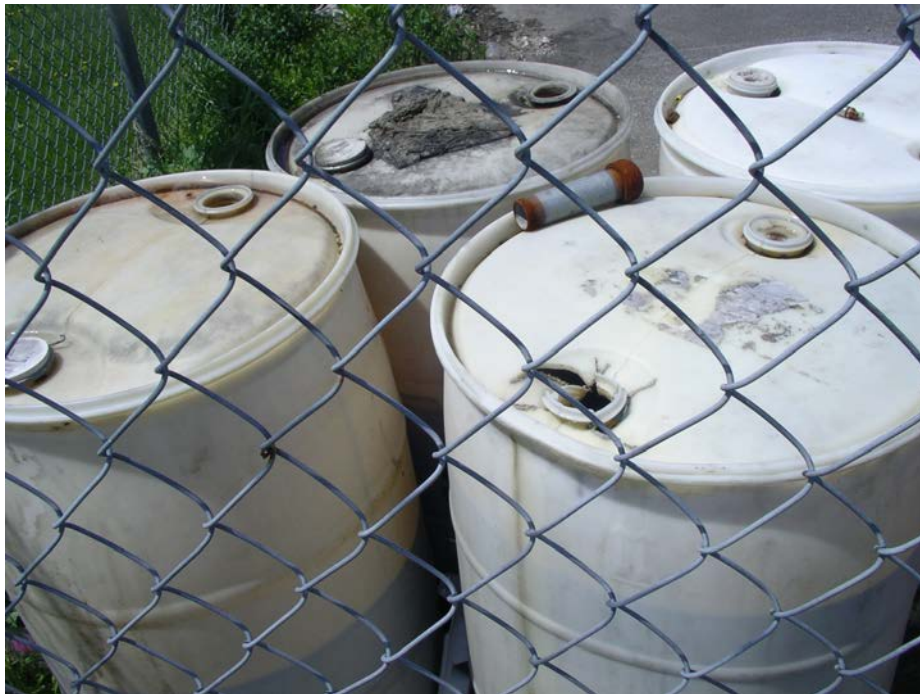
| POTENTIAL POLLUTION SOURCES | | | | | | | | | |
|---|---|---|---|---|---|---|---|---|---|
| HSI-A-506 | Potential (10) | Commercial – automobile repair | ✓ | ✓ | | | | | Unsealed white drums with unknown liquid, uncovered/ outdoors. Could be antifreeze. Plus rusty fuel or petroleum tank outdoors without secondary containment. |

**Figure 4-16: Automobile Repair Facility (HSI-A-506) With Unlabeled and Unsealed 55-Gallon Drums**

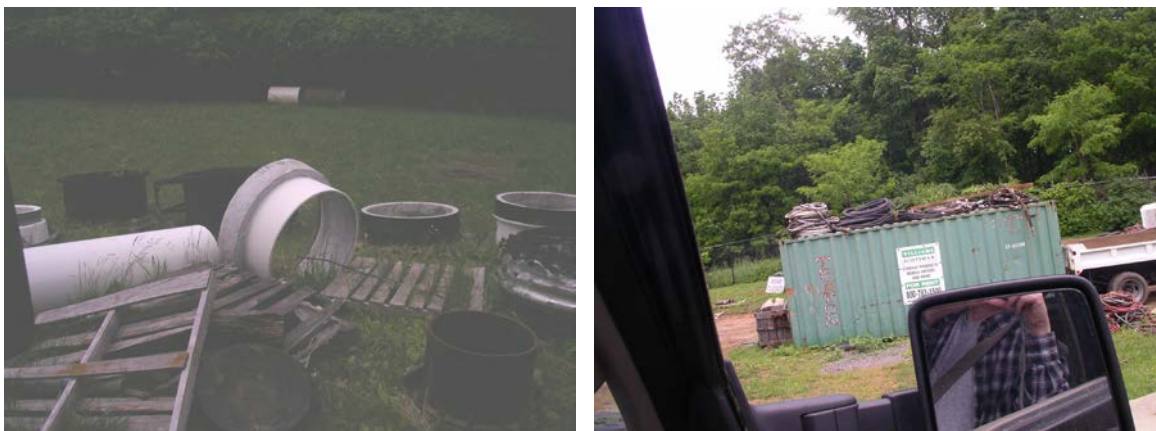
4-17). Also, a chlorine storage facility was observed at the site, which could have dangerous effects on watershed health were a spill or other emergency to occur. For these reasons, developing a stormwater pollution prevention plan (if one does not already exist) is another recommendation at ISI-A-510.

**Figure 4-17: Material Clean-up is Recommended at ISI-A-510.**

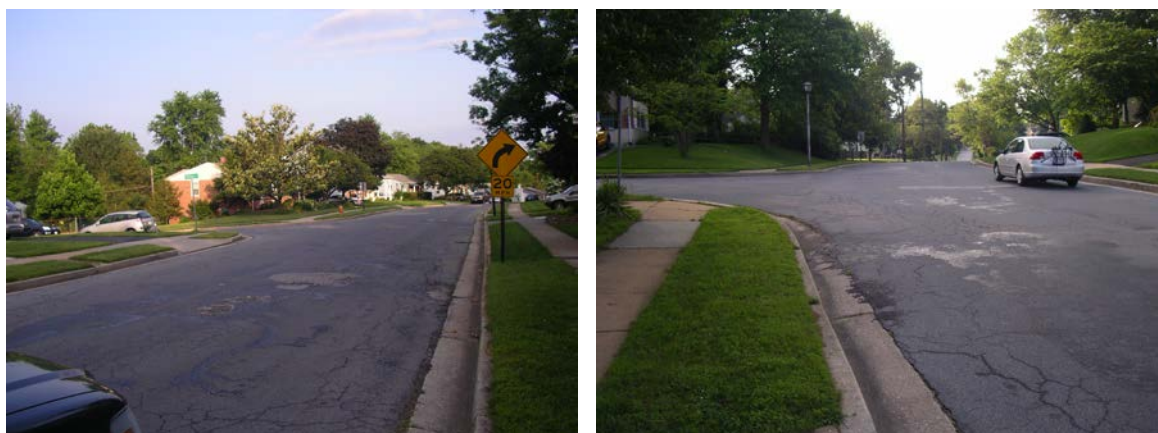
**Figure 4-19: NSA-A-1023 is Recommended for a Variety of Actions.**

NSA-A-1023 (Figures 4-19) was recommended for a variety of actions, including downspout disconnection, rain barrels, rain gardens, storm drain marking, Bayscaping, increasing lot cover, street sweeping and street tree planting. This neighborhood would be ideal for creating an integrated management plan that demonstrates how all of the various strategies can work together in one locale.

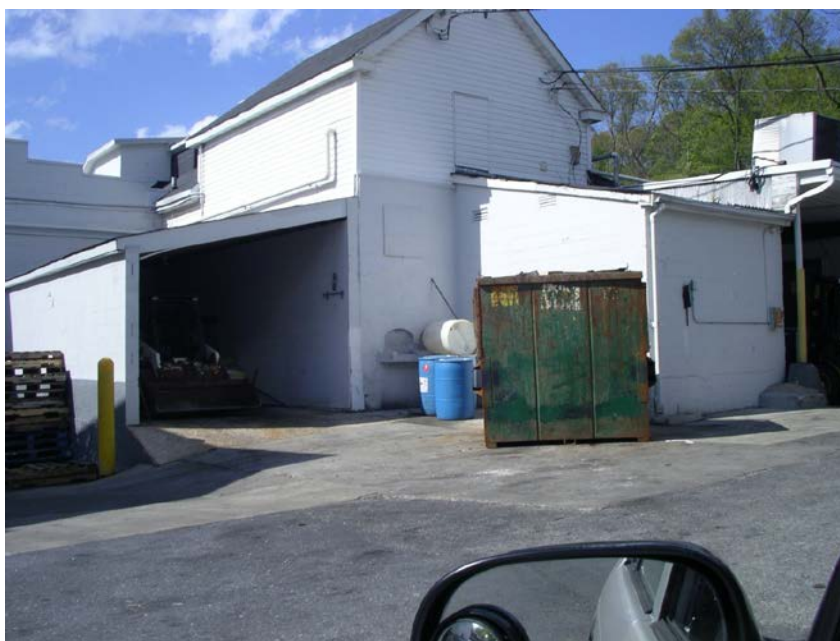
The one HSI in the watershed was a slaughterhouse which was generally quite orderly with the exception of some unmarked 55 gallon drums that were exposed to precipitation (Figure 4-20). The facility also has large fuel tanks. If those tanks exceed 1320 gallons in total, the facility would need a Spill Prevention Control and Countermeasures (SPCC) plan as per the Maryland regulations.

**Figure 4-20: Unmarked Drums Exposed to Precipitation**

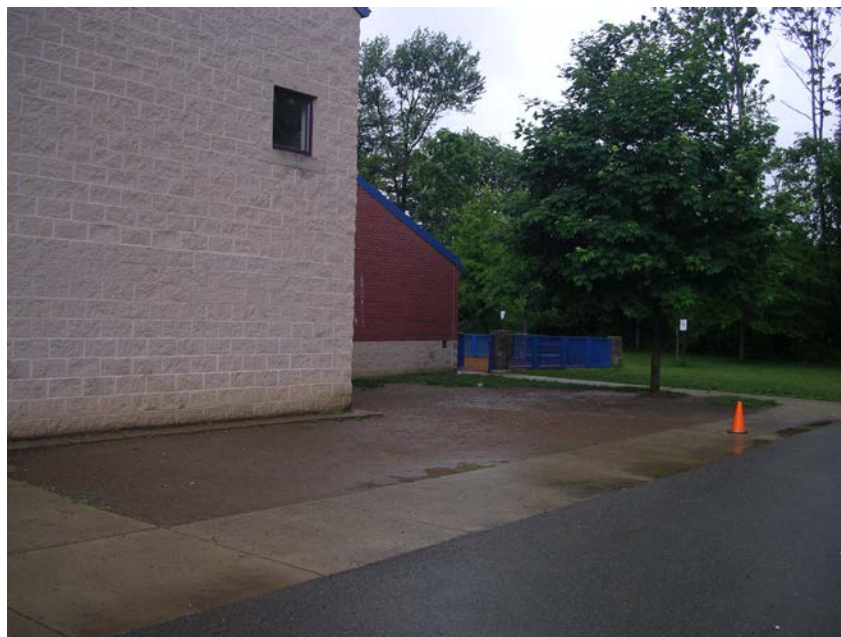
| RECOMMENDED ACTIONS | | | | | | | | | | |
|---|---|---|---|---|---|---|---|---|---|---|
| ISI-A-641 | Westchester Elementary School | Public | ✓ | 3 | ✓ | ✓ | | | ✓ | Some bare ground present in rear of school that drains to stormwater inlet |

**Figure 4-21: Potential Location for Inclusion of a Bioretention Area at ISI-A-641**

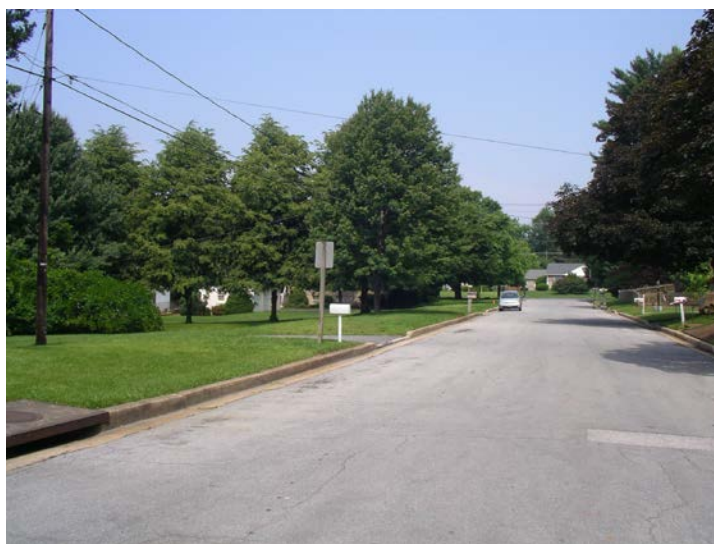
**Figure 4-23: Neighborhoods, Like NSA-A-1094, Have Opportunities for Rain Gardens, Street Trees, and Other Improvements.**

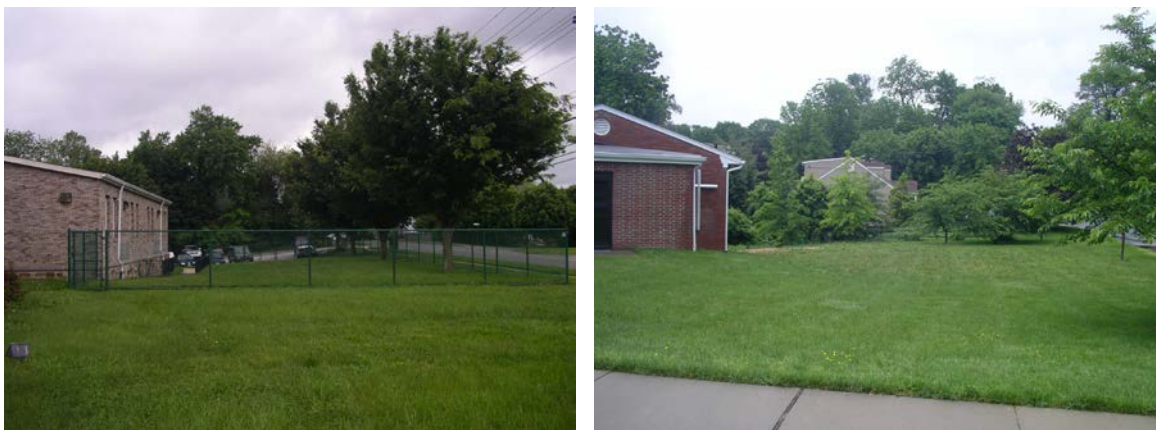
**Figure 4-24: Potential Tree Planting Areas at Faith-Based Facilities in Thistle Run**

Three of the four church facilities assessed in Thistle Run offer opportunities to engage the community in tree planting activities (Figure 4-24). Trees are crucial to the overall health of the watershed—they slow down runoff and the erosion of soil, and they absorb the nutrients that are the main cause of pollutants in local streams and the Chesapeake Bay. Trees also provide habitat for wildlife and help to cool stream temperatures. Involving parishioners in tree planting events can pique interest in watershed stewardship and provide watershed benefits as well.

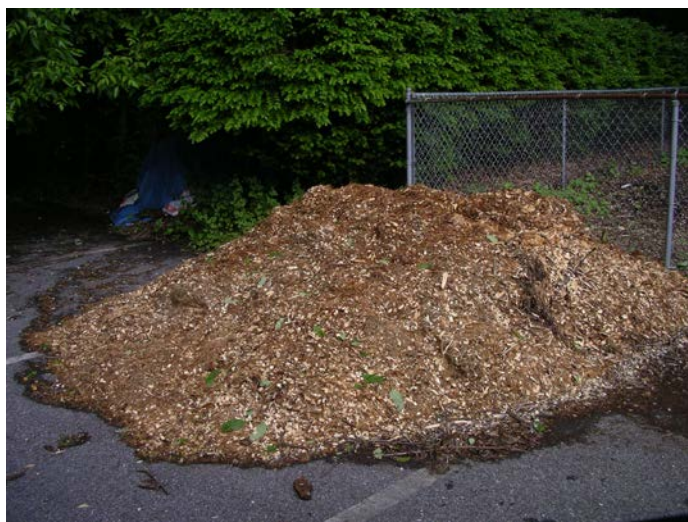
**Figure 4-25: An uncovered pile of mulch at ISI-A-714 could wash away during high storm-flows and provide unnecessary nutrient inputs to downstream waters.**

Stormwater management at the church facilities can additionally be improved in several ways. Reductions in stormwater can be attained by disconnecting downspouts and creating bioretention areas (rain gardens). Bioretention areas are depressed swatches of land with native plants and filter media that enable roof runoff to be captured and treated prior to entering the storm drain/stream system. Signage can be erected with the rain gardens to educate the churches' communities as to the benefits of these practices to watershed health. Education related to proper material and waste management should also be provided, as an uncovered dumpster and uncovered pile of mulch were observed at ISI-A-714 (Figure 4-25), and covered dumpsters located just upslope of stormwater inlets were observed at ISI-A-729 and ISI-A-731. Keeping covers on these dumpsters and material piles, and moving dumpsters away from stormwater inlets are good precautions to undertake to improve watershed health.

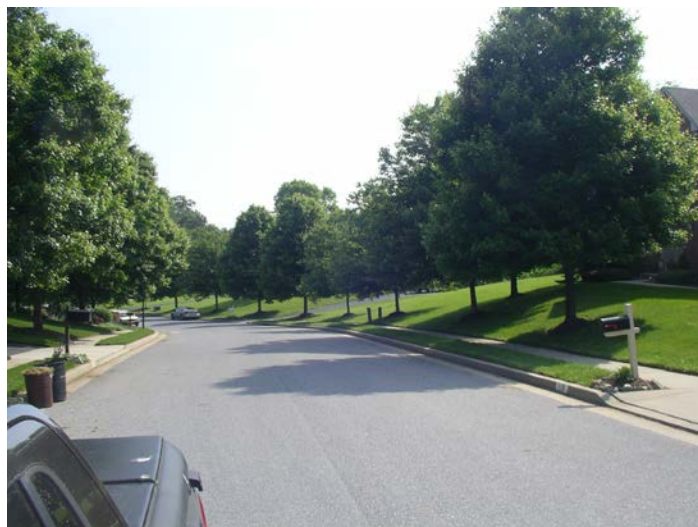
**Figure 4-27: Neighborhoods With Large Yards, Like NSA-A-1050, May Have Available Space for Creating Rain Gardens.**

Rain gardens and storm drain marking programs were recommended for all neighborhoods (Figure 4-27). Both action strategies involve a strong educational component, and may pay off beyond their initial pollutant load reductions. Citizens may begin to develop a sense of how their actions and conditions on their property relate to the health of the Chesapeake Bay, giving them a stronger sense of connection and ownership that may result in additional restoration and protection activities.

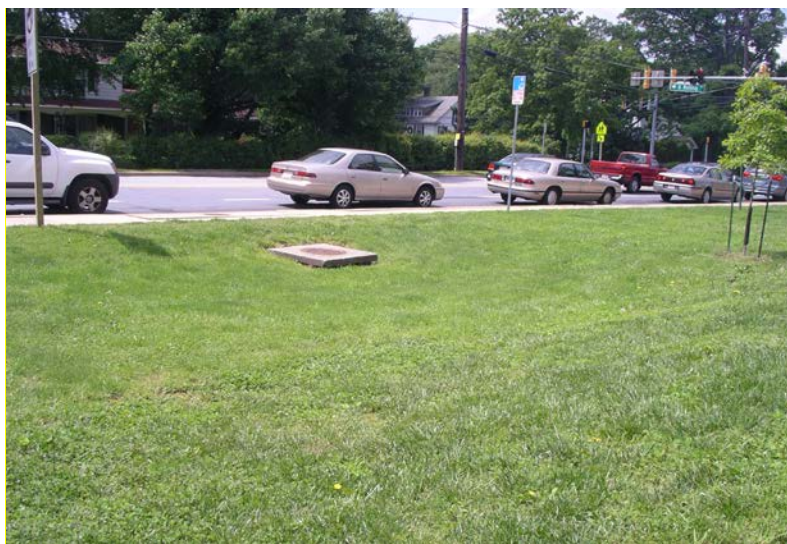
**Figure 4-28: Potential Tree Planting Site at ISI-A-818**

Storm drain marking is also recommended at the public school assessed in this sub-watershed, again offering an excellent opportunity to engage students and teachers in an activity promoting watershed stewardship. While many trees have recently been planted by the school’s PTA, some additional opportunities for tree plantings were identified here and could offer students further hands-on opportunities to improve watershed health (Figure 4-28).

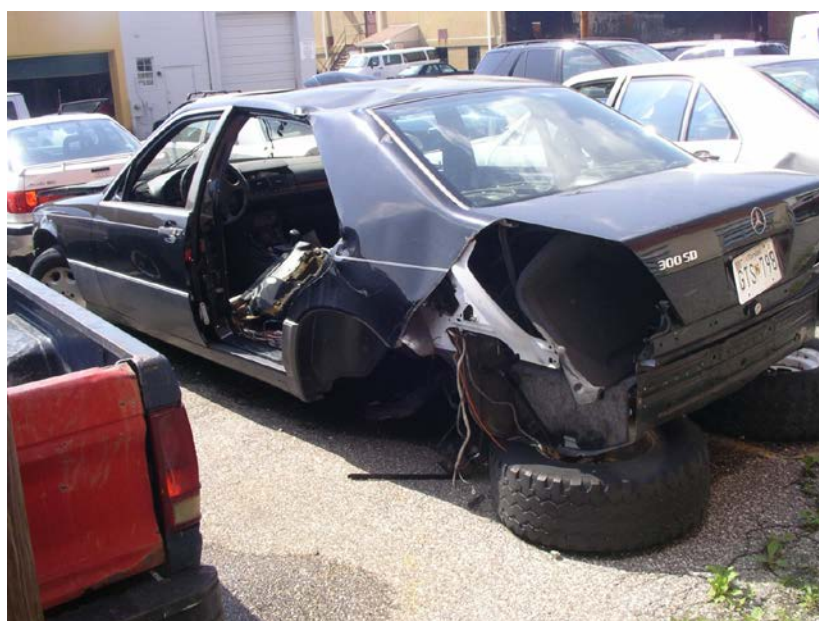
**Figure 4-31: Damaged Vehicles Awaiting Repair in Front of Automobile Repair Shops**

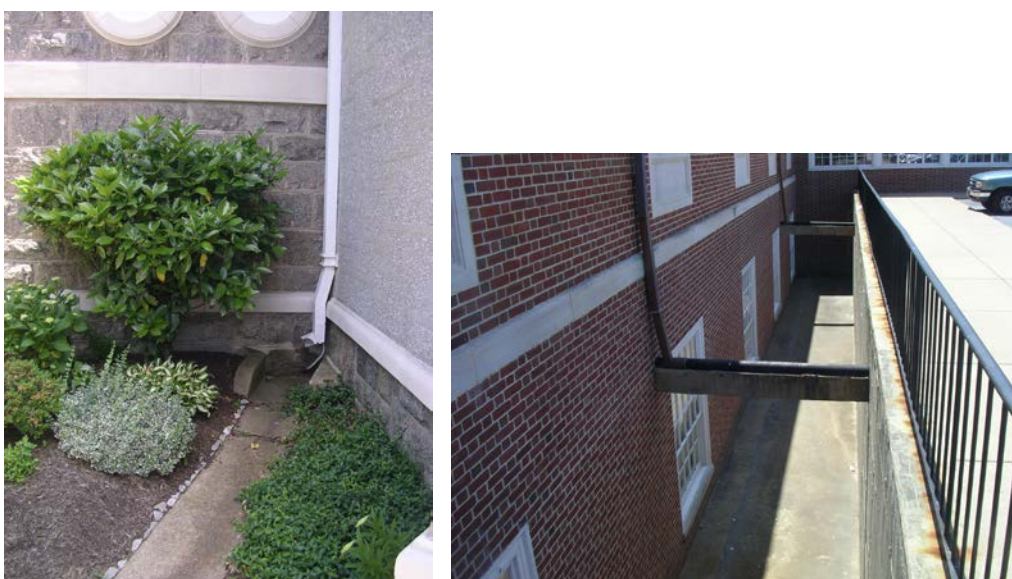
**Figure 4-32: Downspouts at ISI-A-916 Could be Redirected to Improve Stormwater Infiltration.**

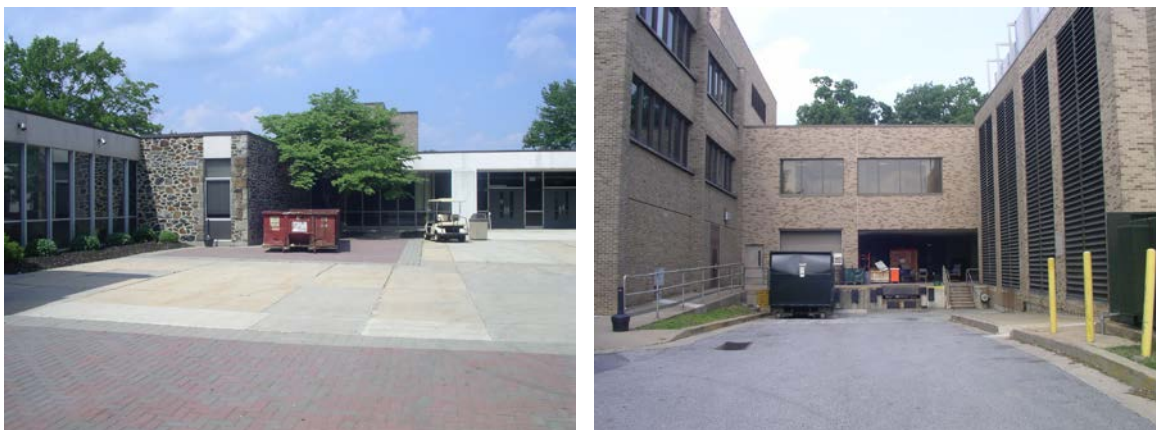
Similarly, several additional opportunities were identified at ISI-A-923, the Community College of Baltimore County, Catonsville Campus. A loading dock and dumpster were identified just above a stormwater inlet with no diversion methods present (Figure 4-33). In addition, a temporary dumpster was noted uncovered at this site. Maintaining covers on dumpsters and taking precautions near inlets are relatively simple actions that can serve as educational opportunities.

**Figure 4-33: Additional Opportunities for Action at ISI-A-923.**

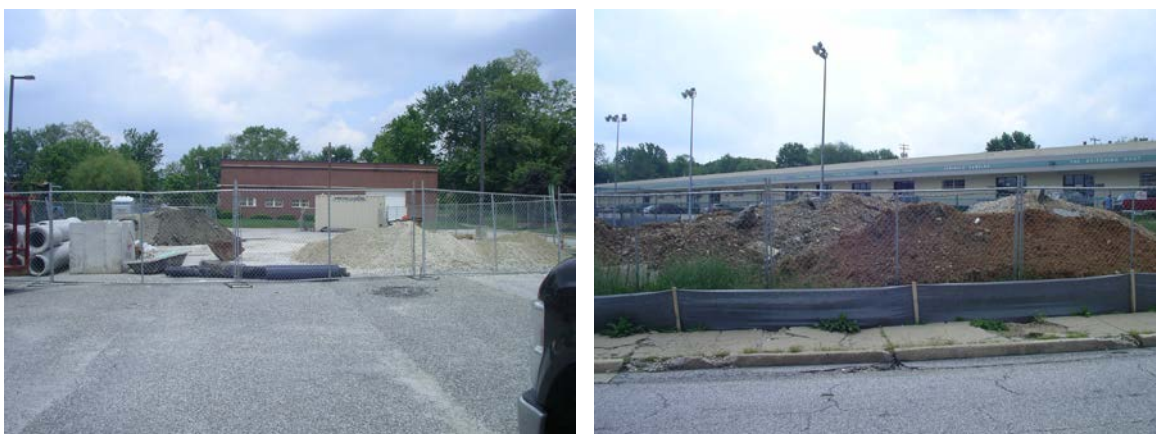
**Figure 4-34: Uncovered Gravel, Dirt, and Other Construction Materials at ISI-A-924 Can Have Significant Effects on Water Quality During a Runoff Event. At This Location, Some Piles Were Properly Surrounded by Silt Fences but Others Were Left Uncontrolled.**

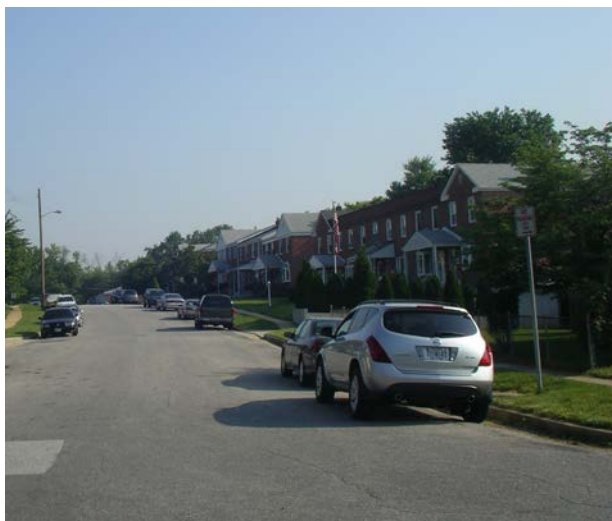
**Figure 4-37: Neighborhoods, Like NSA-A-1057, Have Wide Swaths of Unplanted Turf Between the Sidewalk and the Street and Provide Prime Opportunities for Community Street Tree Plantings.**

This subwatershed offers a large number of opportunities for street tree plantings (Figure 4-37), and most neighborhoods were recommended for increasing lot canopy. These types of actions provide an opportunity for widespread citizen engagement, and help to develop community relationships that might allow for education about practices such as rain gardens and rain barrels.

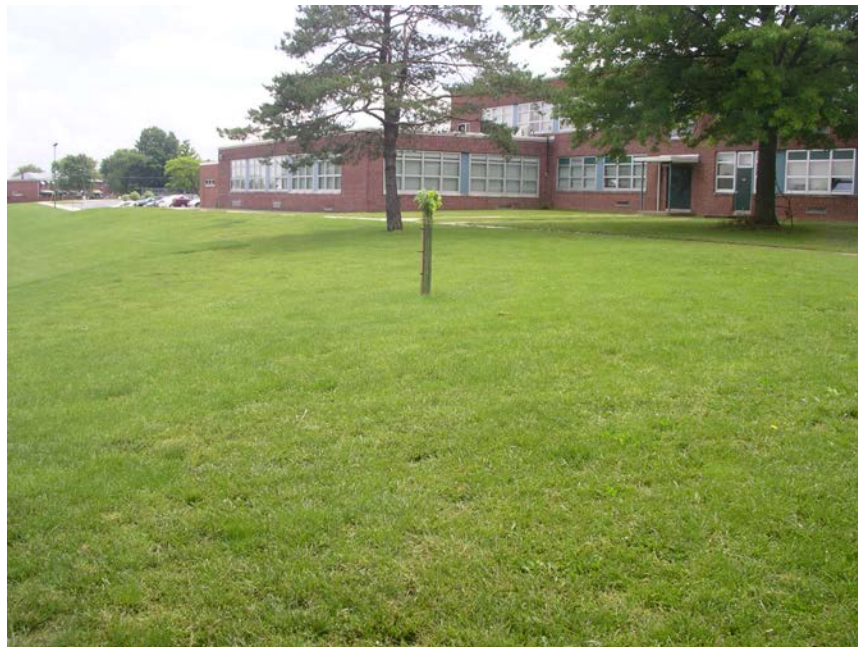
**Figure 4-38: Tree Planting Opportunities Exist at the Institutions Investigated in Herbert Run (W. Br.), Including this Open Space at ISI-A-1121.**

At ISI-A-1121, Arbutus Middle School, parking lot repair was recommended as curbs have begun to disintegrate and are producing erosion points and sediment transport to inlets, especially in the rear parking lot. At the front entrance of the school, two downspouts discharge to impervious surface and would be good candidates for downspout disconnection to a bioretention area/rain garden. This would be a highly visible project that could serve as an educational opportunity for all who enter the main doors of the school. Along the rear property, a stream is present. Gabion baskets line the banks downstream of the bridge crossing and have failed, spilling riprap and large cobble into the stream (Figure 4-39). In addition, other large trash items, including some large barrels, were visible in the stream. The riparian buffer in this area is thin and adding additional trees is recommended. Along with riparian buffer planting, a stream clean-up would be an excellent opportunity to engage the students and teachers in a hands-on activity, and would serve as an educational experience regarding proper trash disposal and management, and of the importance of riparian buffers to stream systems.

Planting trees was recommended at all of the institutions assessed in Herbert Run (W. Br.). Additional trees at these sites can help improve stream quality and watershed health primarily by decreasing the amount of stormwater runoff and pollutants that reach local waters. Trees reduce stormwater runoff by capturing and storing rainfall in the tree canopy and by promoting infiltration of water into the soil. The planting activity can be an educational experience and engage citizens and students alike (Figure 4-38).

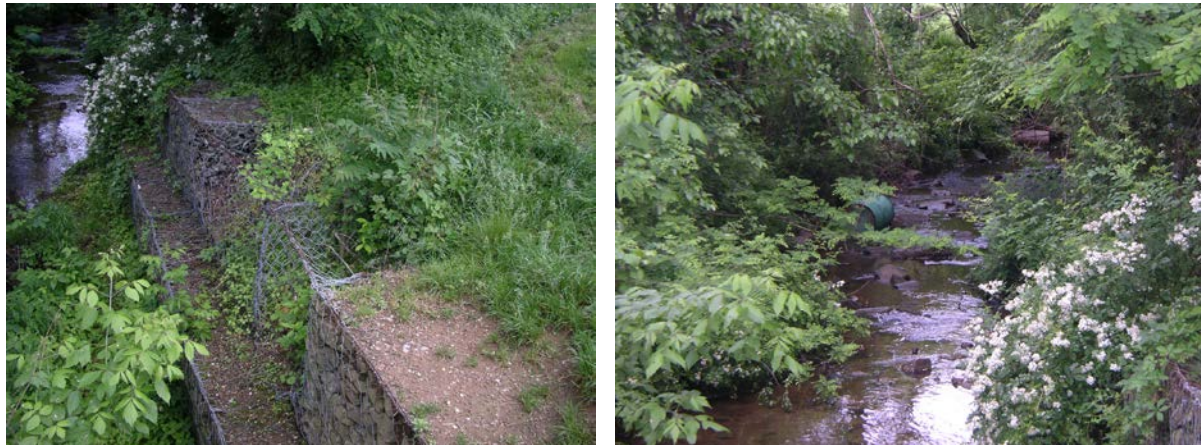
**Figure 4-39: Gabion Baskets Line the Stream Banks Below the Bridge Crossing at ISI-A-1121. Some Baskets Have Failed, as Shown in the Photo on the Left. In Addition, Drums and Other Trash Litter the Stream and Offer an Excellent Opportunity for Student Involvement in a Stream Clean-up.**

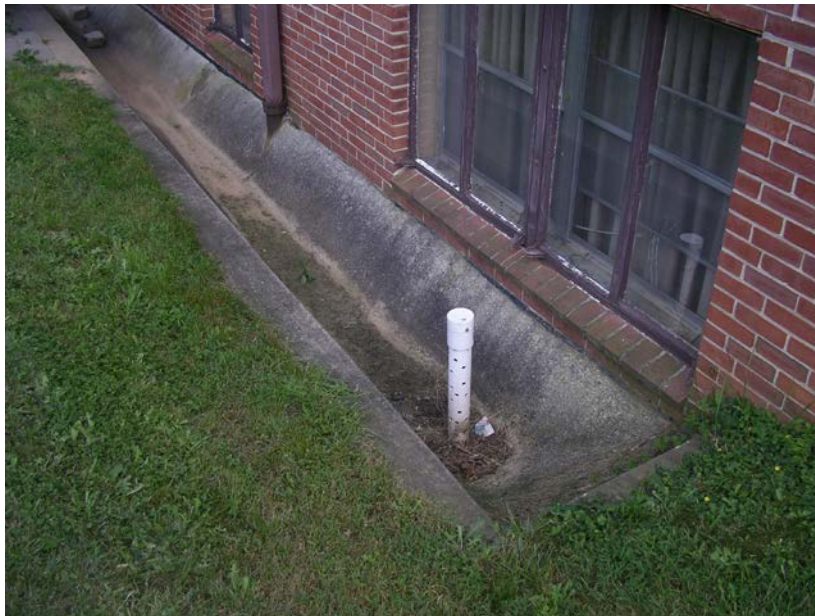
**Figure 4-40: A Concrete Trough Adjacent to the Main Church Building Could be Removed and the Downspouts Redirected at ISI-A-1140.**

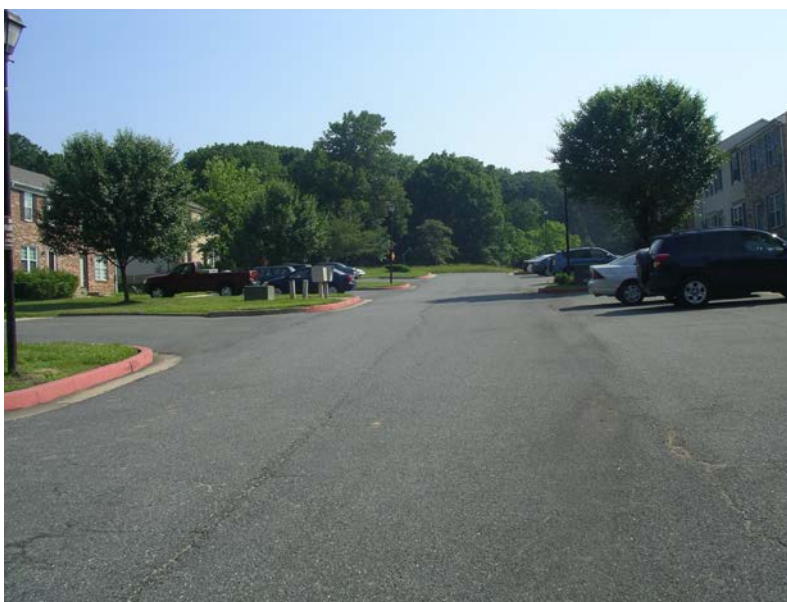
**Figure 4-42: Neighborhoods, Like NSA-A-1062, Have Some Existing Street Trees.**

NSA-A-1062 (Figure 4-42) was recommended for a variety of actions, including rain barrels, storm drain marking, increasing lot cover, street sweeping and buffer improvements. This neighborhood would be ideal for creating an integrated management plan that demonstrates how all of the various strategies can work together in one locale.

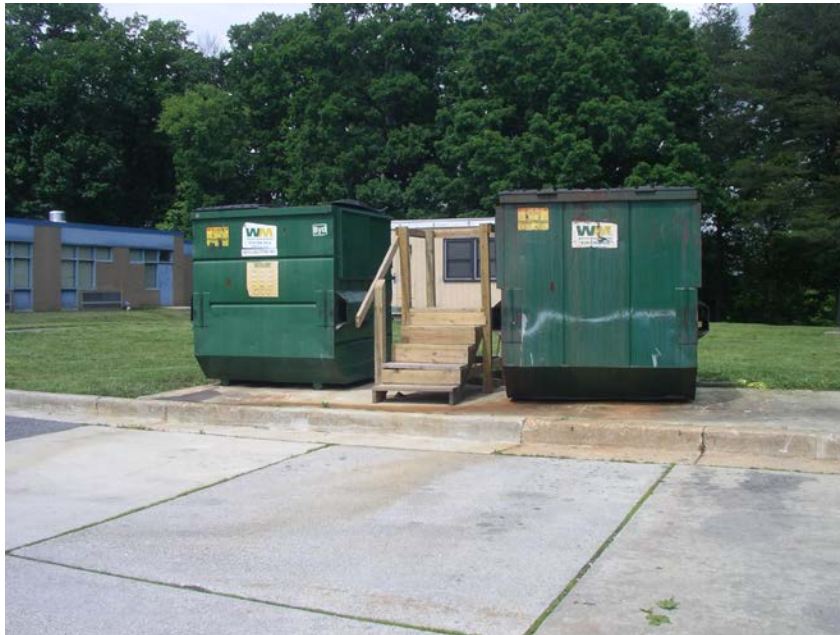
**Figure 4-43: Dumpsters at ISI-A-1226 Show Evidence of Leakage and Should be Repaired, Kept Covered, and Checked Frequently to Ensure Pollutants are Not Leaking Out.**

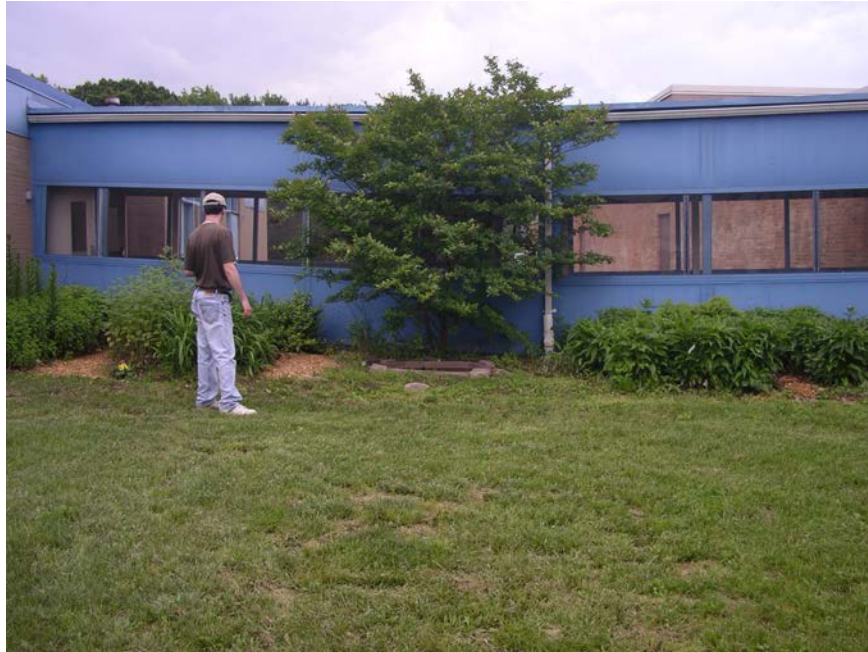
**Figure 4-44: Staff at Relay Elementary School Complained of Flooding that Occurs at the Low Spot of this Breezeway. A Connected Downspout is Present Here and May be Redirected to a Newly Installed Rain Garden that Could Help Remedy the Localized Flooding.**

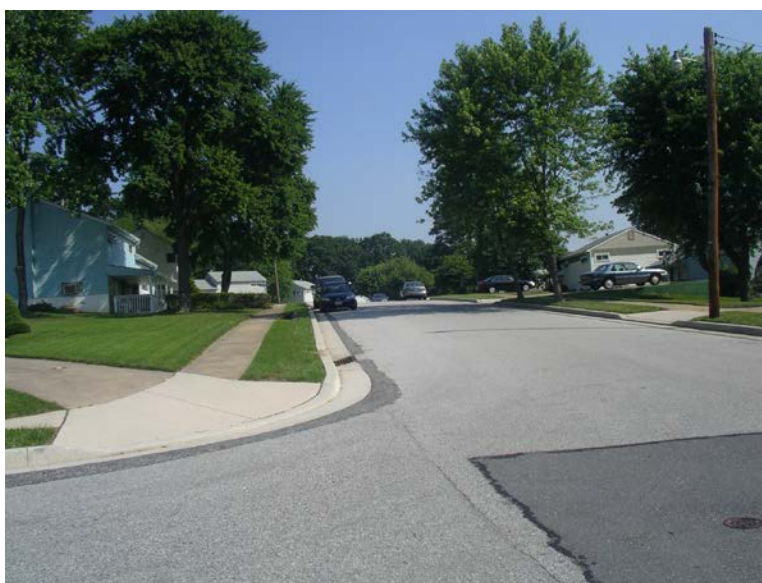
**Figure 4-46: Neighborhoods, Like NSA-A-1060, that Have Large Turf Lawns Provide Ideal Opportunities for Bayscaping and the Installation of Rain Gardens.**

Herbert Run’s single neighborhood, NSA-A-1060 (Figure 4-46), provides opportunities for a wide variety of actions. The relatively large yard size, and lack of landscaping, allows for options like Bayscaping and rain garden installation. A program that helps with planting street trees may engage the community with an introduction to their place in their watershed, and encourage them to take next steps, such as installing rain barrels on their property.

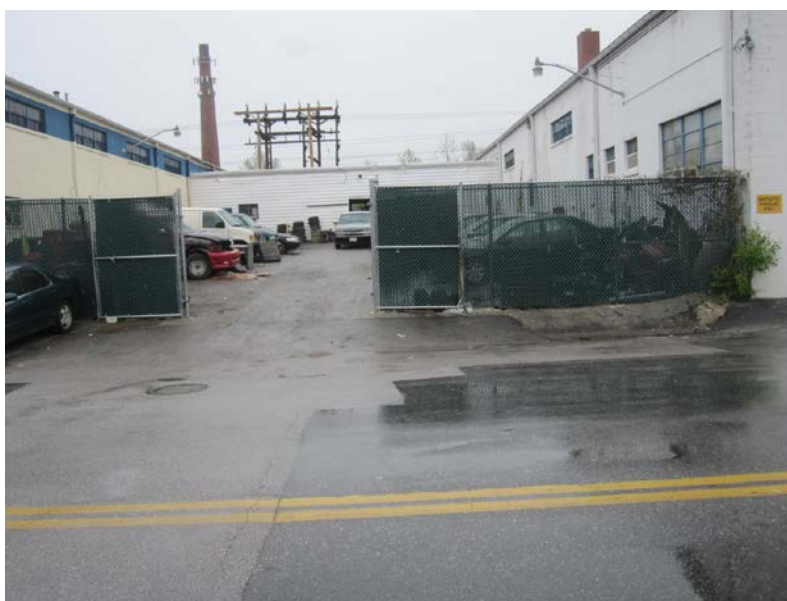
**Figure 4-47: Automobile Repair Facility at HSI-A-1328**

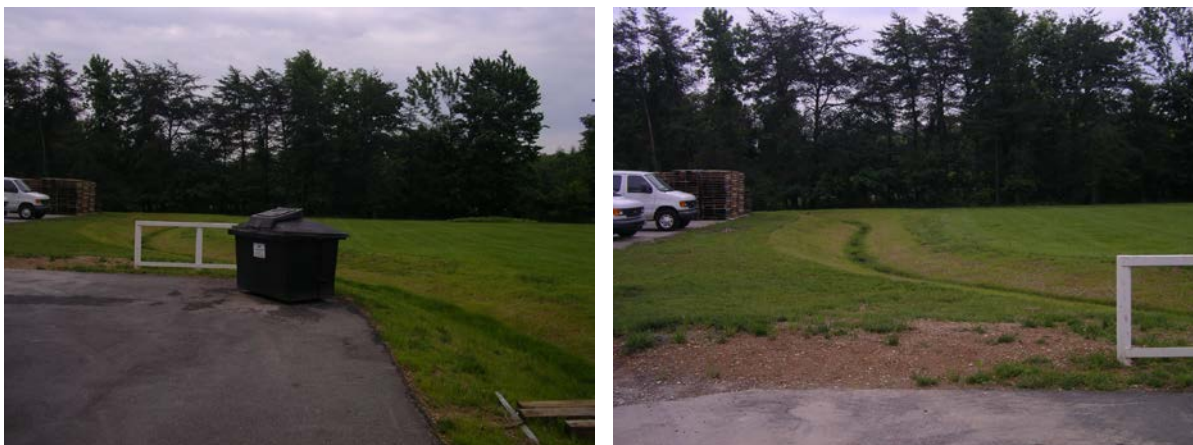
**Figure 4-48: A Grease Receptacle Sits Adjacent to a Stormwater Swale, With No Secondary Containment, at ISI-A-1338. Precautions Should be Taken for This Receptacle in Case of a Spill, Leak, or Puncture to Avoid Polluting the Swale and Stream Below.**

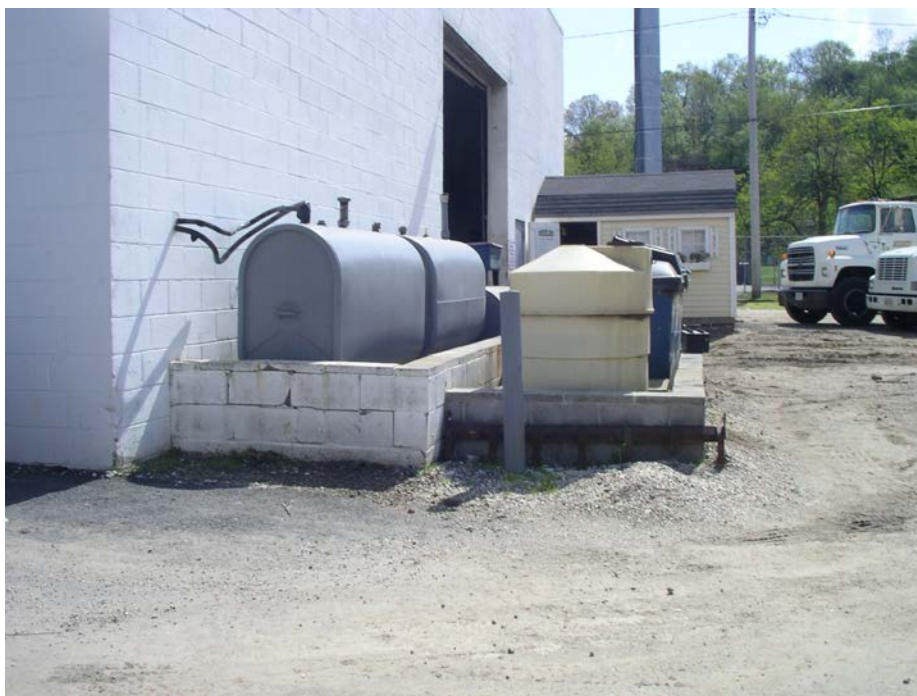
**Figure 4-50: Equipment Rental Company With Cracked Containment for Oil Storage at HSI-A-1415**

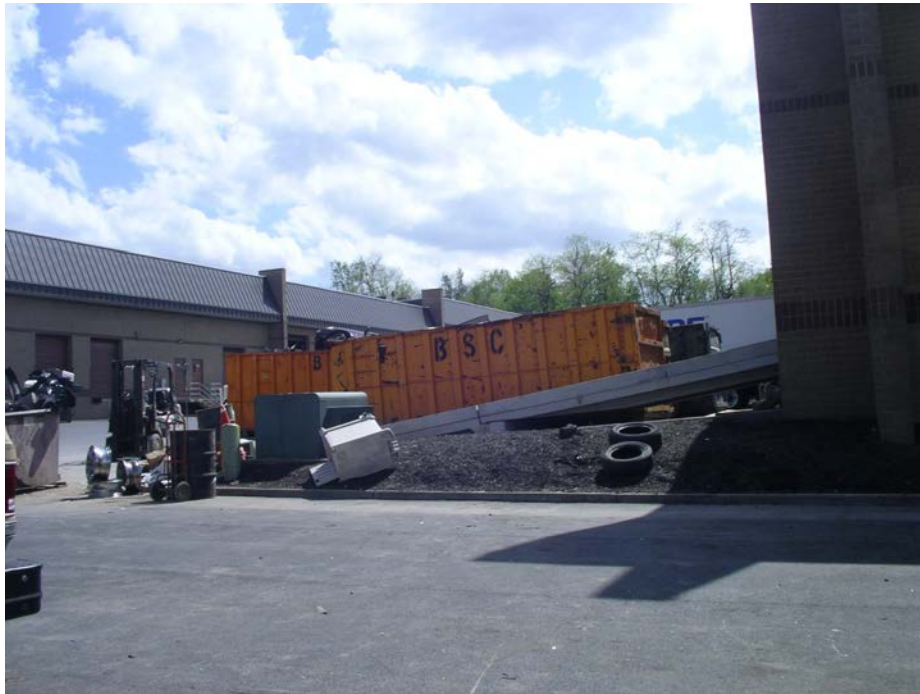
**Figure 4-51: Metal Recycling Facility at HSI-A-1416**

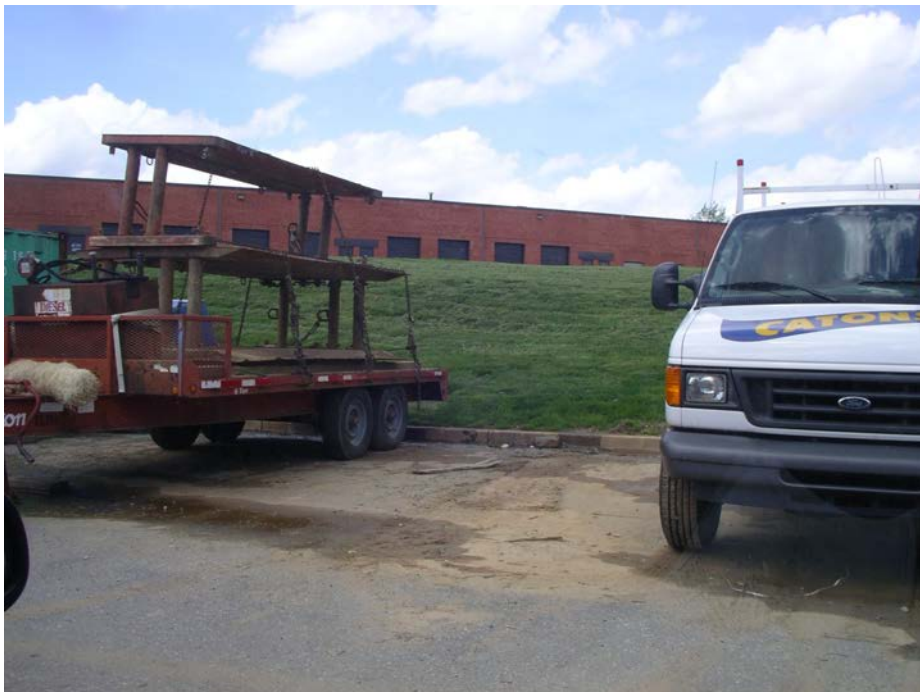
**Figure 4-52: Sediment From Excavating Equipment Being Stored in Rear Parking Lot of Plumbing Repair Facility at HSI-A-1413**

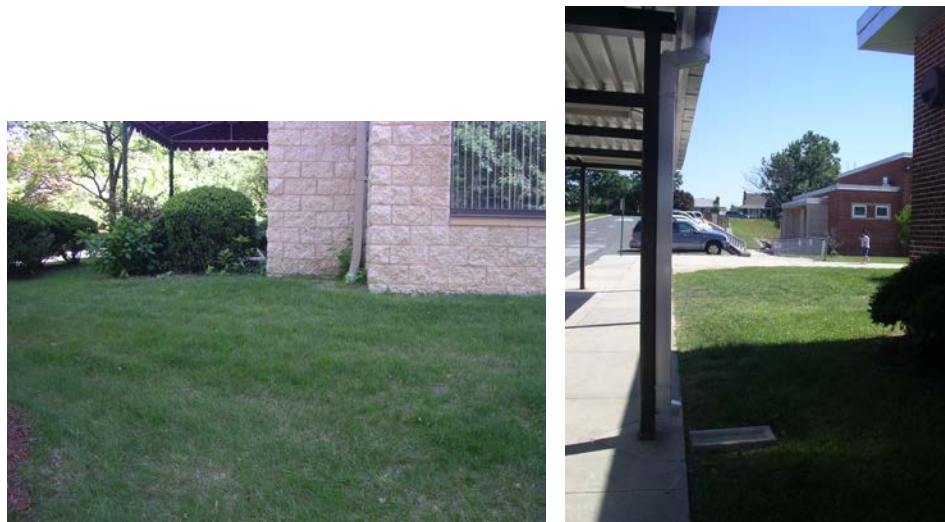
**Figure 4-53: Opportunities Exist for Downspout Disconnection and Creation of Rain Gardens at ISI-A-1422 (left) and ISI-A-1439 (right).**
