# LOWER PATAPSCO RIVER SMALL WATERSHED ACTION PLAN

## Volumes I and II

Baltimore County Department of  
Environmental Protection and Sustainability

*May 2012*

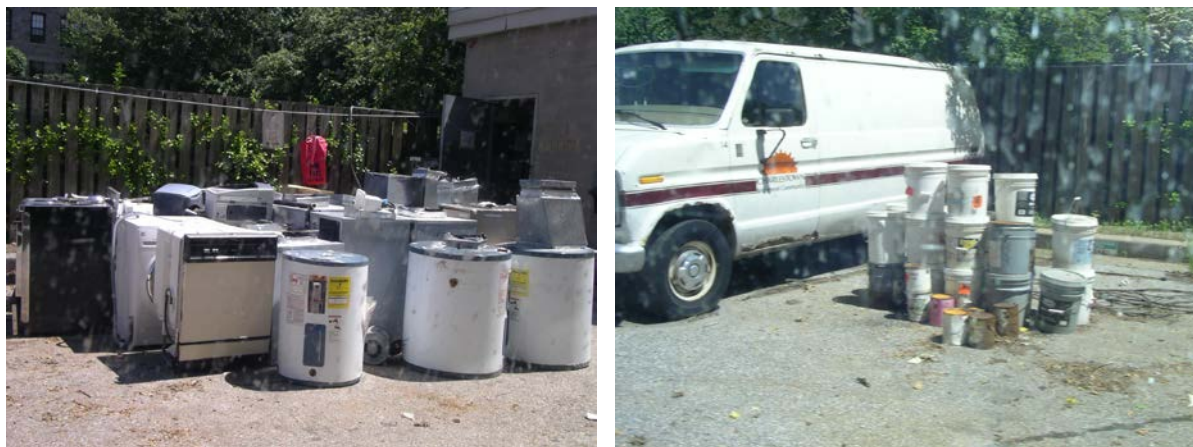
**Figure 4-54: Poor Materials Storage Practices Were Observed at ISI-A-1422.**

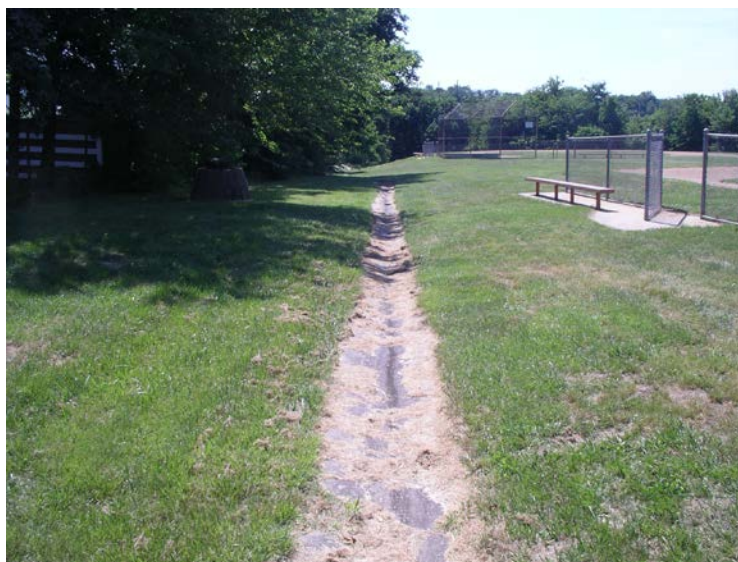
**Figure 4-55: Grass Clippings Accumulate in a Concrete Gutter at ISI-A-1439. During Storms, These Clippings Will be Washed Away and Contribute to Nitrification in Downstream Waters. Removal of This Impervious Gutter is Recommended, as it Could be Converted to a Pervious Swale.**

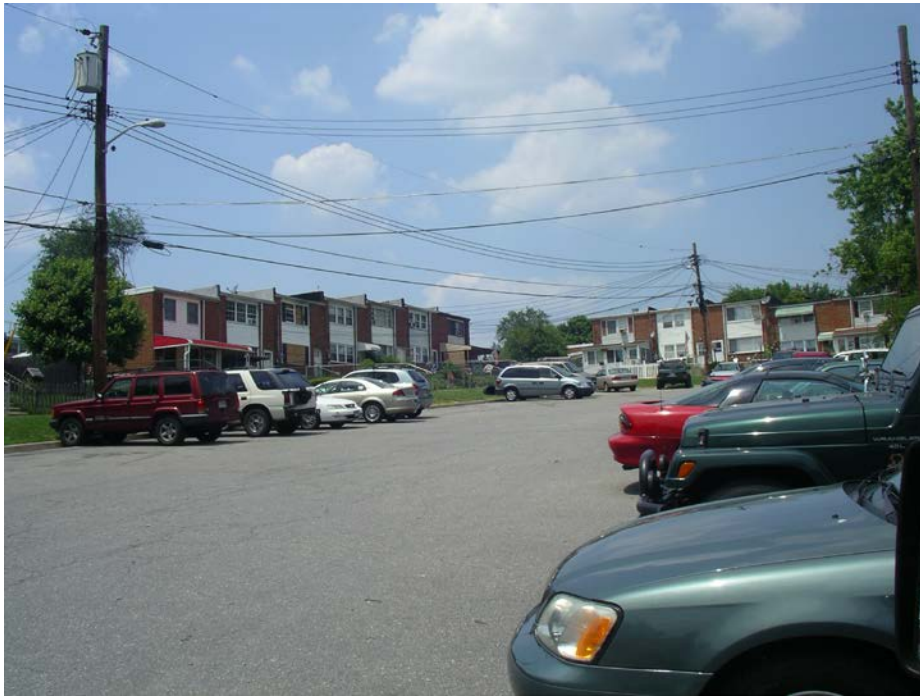
**Figure 4-57: Multi-family Parking Lots, Like This One in NSA-A-1075, Provide an Opportunity to Control Stormwater Runoff From a Single, Large Area of Impervious Surface, and Could Result in Pollutant Load Reductions.**

Many of the neighborhoods had opportunities for a variety of actions to be implemented in one locale. Patapsco River-A5 was the only subwatershed in the Lower Patapsco with neighborhoods that were recommended for trash management. In addition, two parking lot retrofits were recommended, meaning the implementation of BMPs to capture and treat runoff from these impervious surfaces (Figure 4-57). Two neighborhoods also were recommended for a large number (> 40) of street trees and may provide excellent opportunities for involving a large group of citizens and educating them about their role in the health of their local watershed and the Chesapeake Bay.

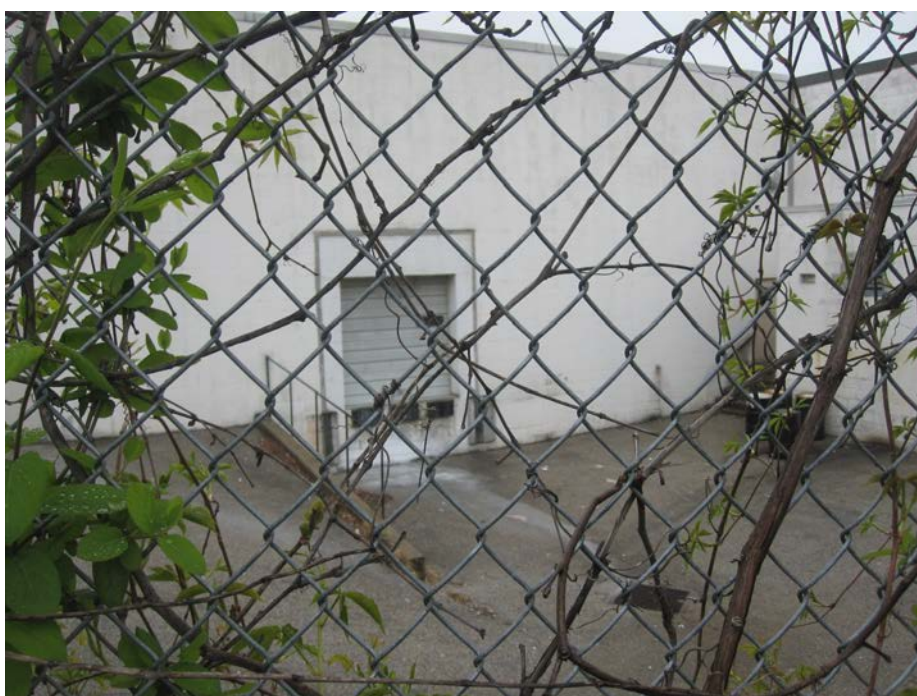
**Figure 4-58: White Staining From Loading Dock and 55-Gallon Drums, Both Proximate to Storm Drain at HSI-A-1520**

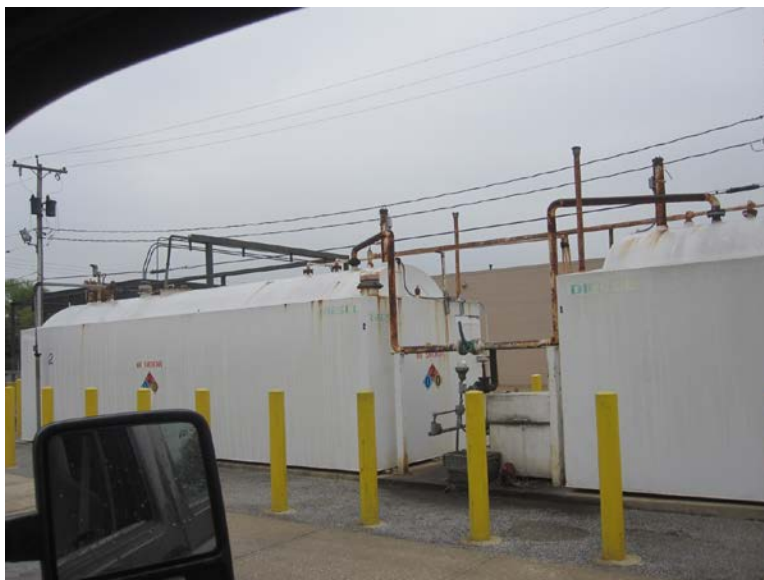
**Figure 4-59: Rusting fuel lines and signs of past spills at above ground fuel storage tanks at HSI-A-1525**

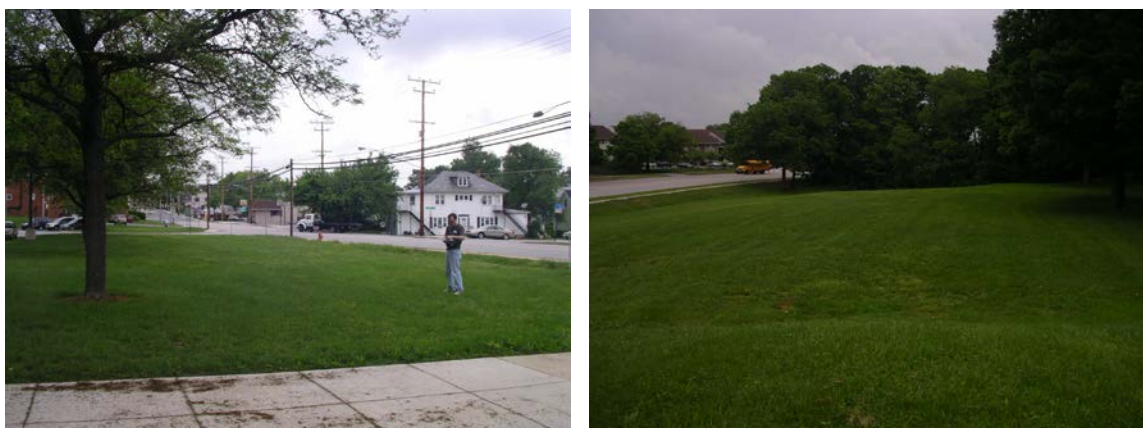
**Figure 4-60: Potential Tree Planting Sites are Present at ISI-A-1536 and ISI-A-1537.**

Storm drain marking was recommended at all three institutions. Storm drain marking can serve as an educational opportunity for the students and faculty of the schools and the members of the American Legion, as well as a visual reminder of the downstream effects on water quality of actions on site. At both of the schools, tree planting was recommended (Figure 4-60). Trees reduce stormwater runoff by capturing and storing rainfall in the tree canopy and by promoting infiltration of water into the soil. Tree planting is an excellent activity to engage students and staff in a hands-on educational opportunity that will result in water quality improvements.

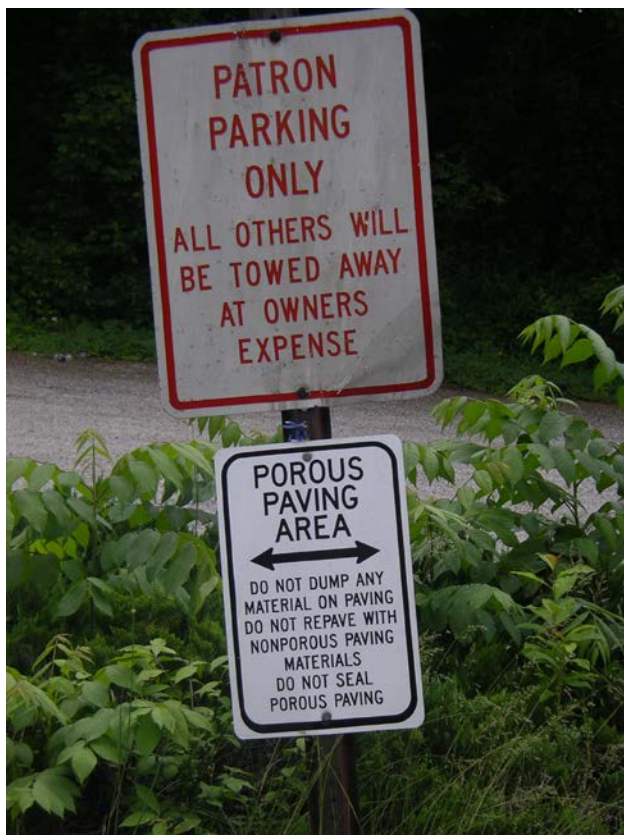
**Figure 4-61: A Porous Parking Lot Surrounds ISI-A-1527.**

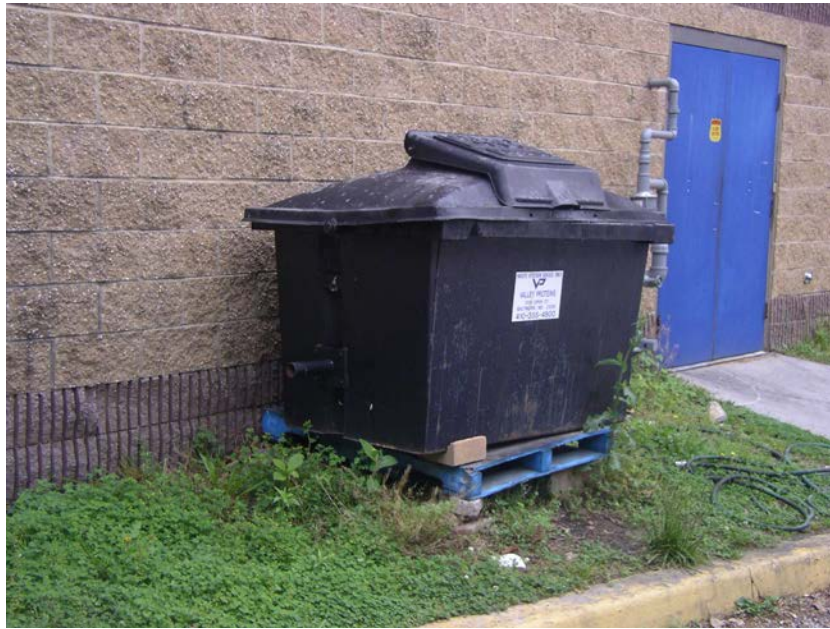
**Figure 4-62: A Grease Receptacle Sits Above Porous Pavement at ISI-A-1338. Precautions Should be Taken for This Receptacle in Case of a Spill, Leak, or Puncture, as the Porous Pavement it Sits on Would Absorb any Spills and Allow Them to Seep into the Ground, Eventually Entering Nearby Streams.**

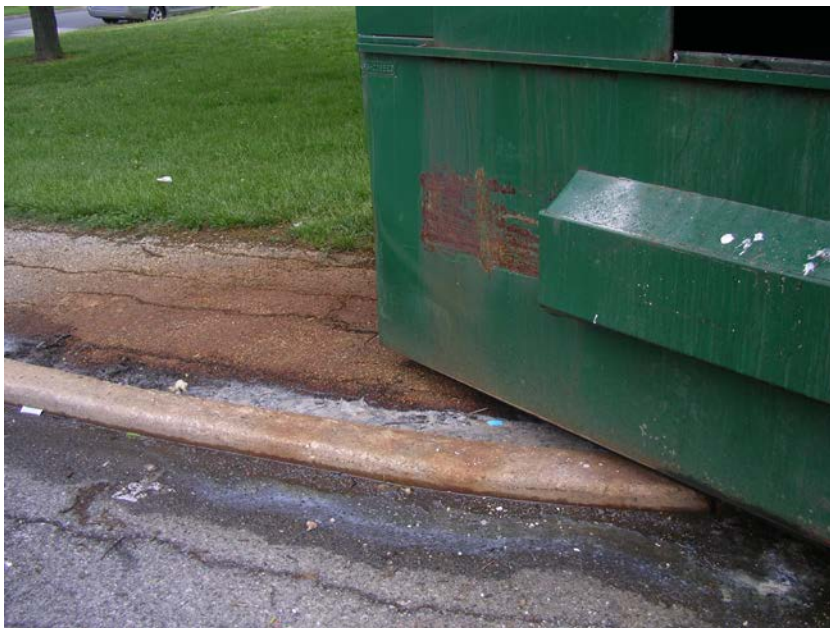
**Figure 4-63: A Leaking Dumpster at ISI-A-1537**

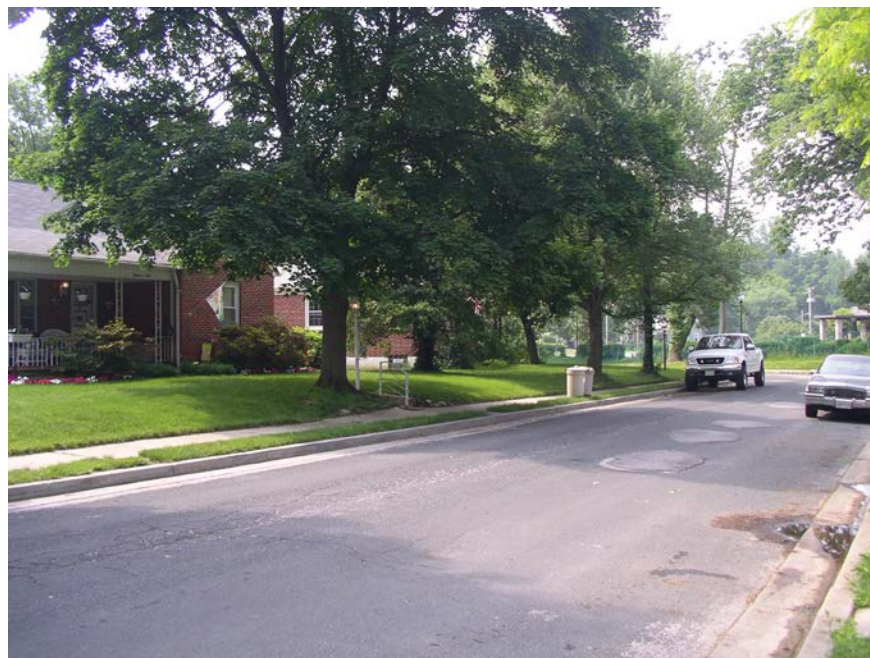
**Figure 4-65: Neighborhoods, Like NSA-A-1032, Provide Good Opportunities for Water Quality Improvements.**

Several neighborhoods, particularly NSA-A-1026, NSA-A-1032, and NSA-A-1088 were recommended for a variety of actions, including downspout disconnection, rain barrels, rain gardens, storm drain marking, Bayscaping, increasing lot cover, and street sweeping (Figure 4-65). These neighborhoods would be ideal for implementing integrated management that demonstrates how all of the various strategies can work together in one locale.

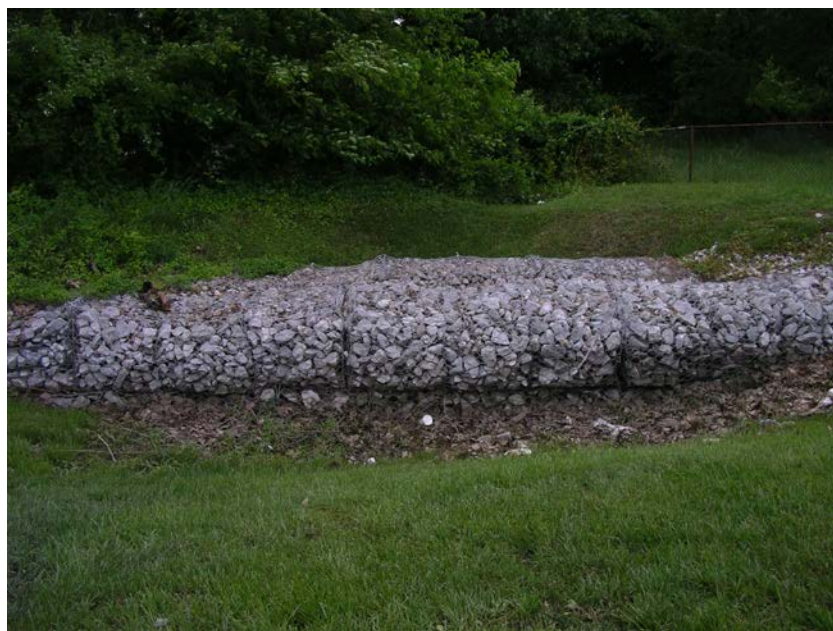
**Figure 4-66: A Gabion-lined, Grassy Swale Runs Parallel to the Parking Lot at ISI-A-1633.**
